Technical note

Testing of EQ and EQP LON wiring prior to startup of system

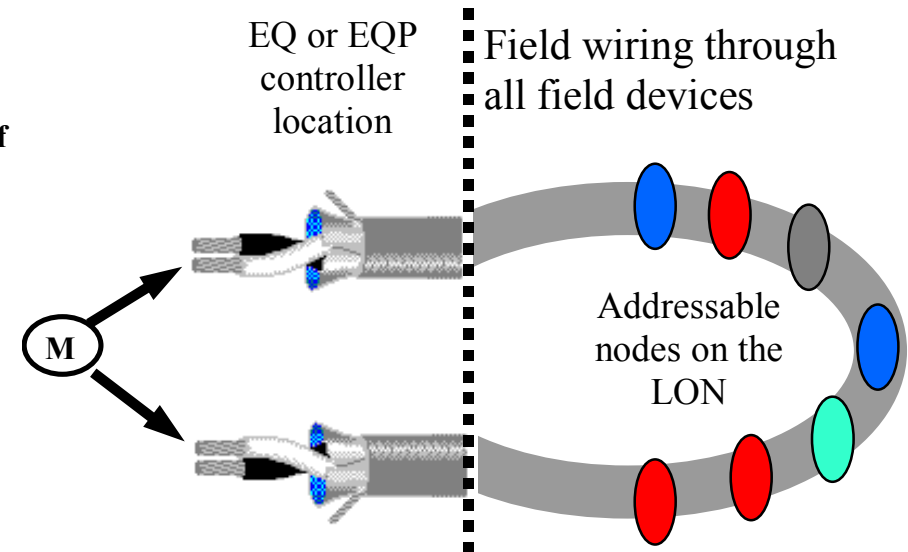
Using an ohm meter measure the resistance of the following :
(This example shows the color code for Beldon 8719, your LON wires may be a different color but the same color should be used throughout)

White to White *
Black to Black *
Shield to Shield (drain wires) *

White to Black **Should be open**
White to Earth (not shield) **Should be open**
Black to Earth (not shield) **Should be open**
Shield to Earth **Should be open**

* The resistance of these three will depend of the LON length and the resistance per 1000ft or 1000m of the wire used.
Example: LON is 3500 ft (loop length). Resistance from wire spec-sheet is 4.5 ohm per 1000ft. White to White and Black to Black should be approx. 15.75 ohms.

The resistance of Shield to Shield will be slightly lower then the White to White or Black to Black resistance and is independent of any NE's, RSU's or PLR's.

Any resistances noted from White to Black, White to Earth, Black to Earth or Shield to Earth indicate a short or partial short and will effect the ground fault monitoring and functionality of the system. They should be found and cleared.

The resistances measured from White to White and Black to Black should be the same and should be near the calculated resistance.

If the length is unknown, estimate the resistance and see if one or both are near the calculated value. If one is near but the other is higher investigate why and get them to read the same. Typical causes are: loose wires in field device terminals, loose J-box connections, loose ribbon cables in DCU's, IDC's SAM's, ARM's, loose plug-in sensor assemblies in Eclipse gas detectors.
